FEATURES	DESCRIPTION & CONDITION	SIG	QUEENS GARDENS SEDBERGH GAZETTEER	RECOMMENDATION	ACTION NOTES
<p>STRUCTURES</p> <p>QUEEN VICTORIA MEMORIAL: SETTING & SENTIMENT</p>	<p>It is not unusual to find a statue or other memorial to Queen Victoria in the nation's public spaces, and buildings, parks, cathedrals and churches. For example, there are ten substantial statues of Victoria in the North-west of England alone¹.</p> <p>It is unusual that this memorial, its sentiment & setting, were conceived, designed & constructed at the same time - an opportunity which Mrs. Florence Anne Upton-Cottrell-Dormer and Thomas Mawson exploited to great effect, to create dramatic landscape theatre (albeit one that the instigator could never have seen reach maturity²). This composition remains substantially intact.</p> <p>The superbly-carved cross, some sixteen feet tall, stands on the highest point of the site and is approached from the principal entrance, through the 'dark vale', before ascending via the broad processional steps to the memorial bathed in light.</p> <p>It is for these reasons that we consider the extant memorial and its designed setting to be of major significance.</p>	<p>1</p>

FEATURE

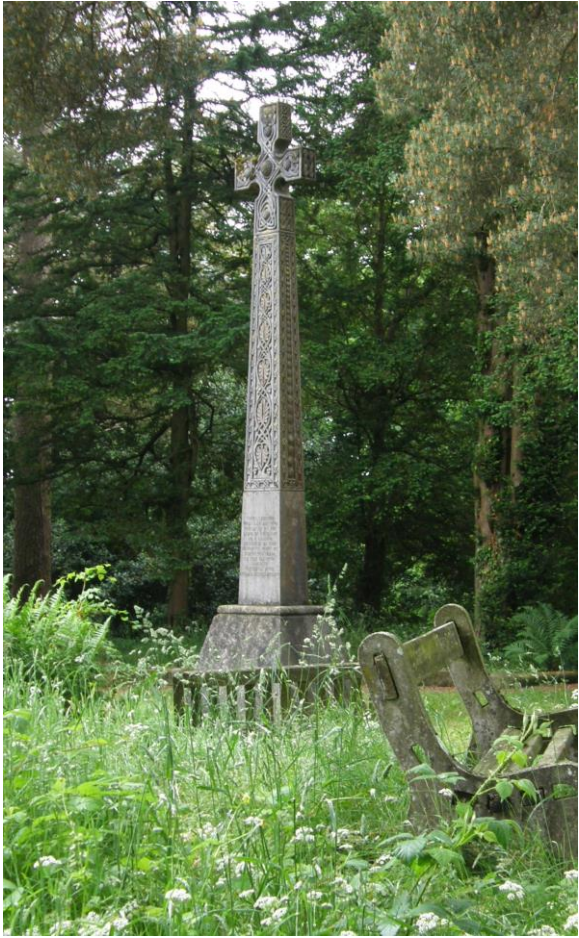
<p>The Memorial Anglo-Celtic Cross</p>	<p>Interpretation Cumbria has a number of the most important Celtic / Anglo-Saxon crosses in the country, as well as Ruskin's cross at Coniston; both the latter & Queen's Gardens' cross were carved by H.T. Miles. These form a fascinating theme in wider Arts & Crafts / Northern English Identity trails</p>	<p>Consider whether more information can be found about H.T. Miles, of Ulverston.</p>

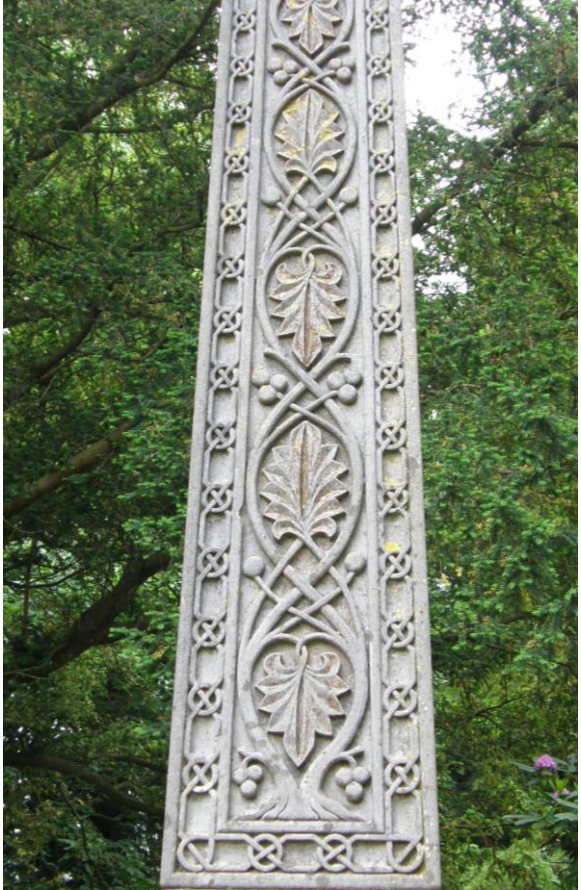
FEATURES	DESCRIPTION & CONDITION	SIG	QUEENS GARDENS SEDBERGH GAZETTEER	RECOMMENDATION	ACTION NOTES
<p>STRUCTURES</p> <p>QUEEN VICTORIA MEMORIAL</p> <p><i>(continued)</i></p> <p><i>The Anglo-Celtic Memorial Cross</i></p>	<p>Inscription on the north face reads: VICTORIA, QUEEN, EMPRESS 1837 – 1901 REVERED, BELOVED, REMEMBERED</p> <p>It is interesting to note that the cross was carved by H. T. Miles, the sculptor who was also responsible for carving the even more intricate Anglo-Celtic memorial cross to John Ruskin. Designed by his friend W. G. Collingwood, an expert in ancient crosses, Ruskin's cross in Coniston churchyard predates the Queen's Garden cross by no more than a year.³</p> <p>The Historic England Listing states that the cross is sandstone. The crisp definition of the carving after over one hundred years' exposure to hill weather suggests perhaps a hard millstone grit or similar type of sandstone was used.</p>

<p>Elaborate carving of carved interlace and strap work with a central panel of foliate decoration</p>		<p>Research & compile information about Anglo-Saxon crosses in the area, & anything further about Ruskin's cross & other Anglo-Celtic pieces of ornament executed in c.1900.</p>

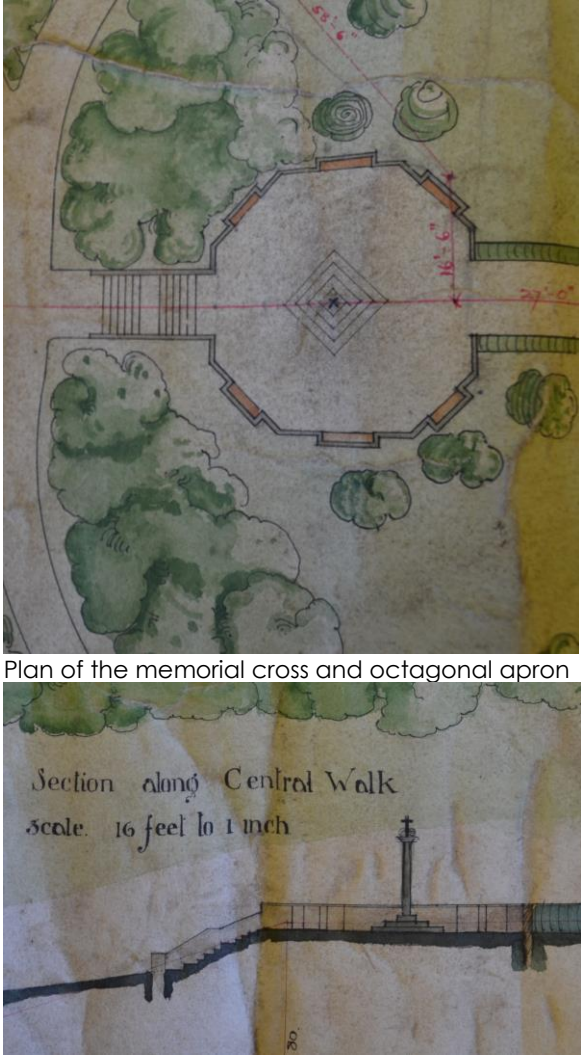
<p>Plan of the memorial cross and octagonal apron</p> <p>Section along Central Walk scale. 16 feet to 1 inch</p> <p>Section along the principal axis (Central Walk)</p>	<p>Interpretation</p> <p>The Mawson plan – held by Sedbergh History Society – offers an engaging vehicle for facilitating enhanced understanding & enjoyment of the Gardens, as well as lessons in the process of design.</p>

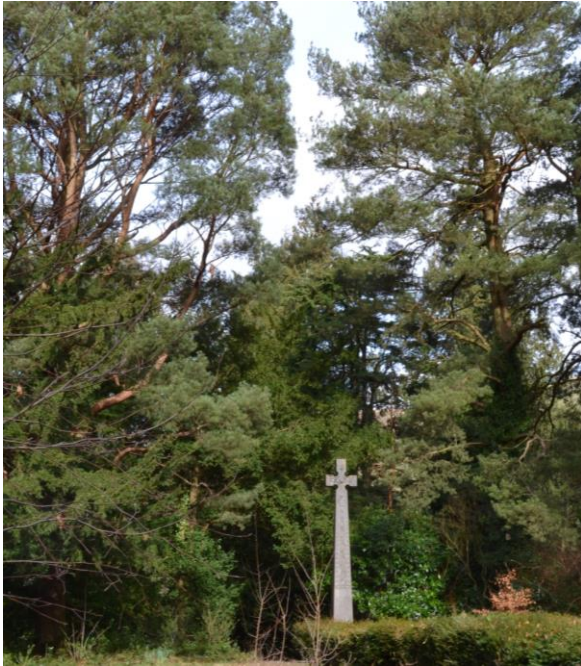
<p>Fine group of Scots pine flanking the Memorial</p>

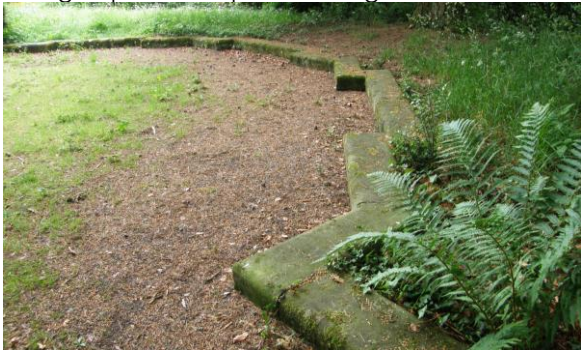
<p>West side of the stone Octagon</p>	<p>Interpretation</p> <p>The contribution to the poetic narrative made by trees selected & composed by Mawson is a key element of this layout. Discussion of the symbol & poetry in the Gardens, & how this may contribute to our understanding of the nature of design, & local & British history, would be productive.</p> <p>Informed management of compositional motifs is essential.</p>

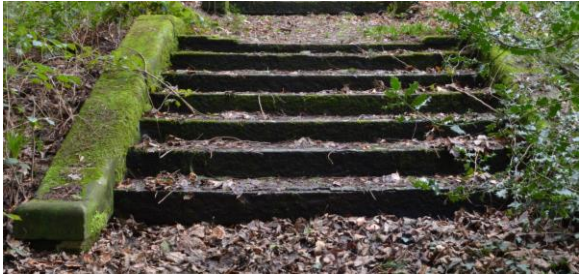
FEATURES	DESCRIPTION & CONDITION	SIG	QUEENS GARDENS SEDBERGH GAZETTEER	RECOMMENDATION	ACTION NOTES
<p>STRUCTURES</p> <p>PROCESSIONAL FLIIGHT OF STEPS TO THE MEMORIAL</p> <p>(continued)</p> <p>Bottom Steps Flanking Walls</p>	<p>The bottom section of steps comprises seven risers / treads flanked by the low walls - all of which appear to be present, albeit in a various states of repair.</p> <p>The low flanking walls have considerable moss growth and indication of bramble, some of which may well have been cleared by volunteers, although the presence of invasive plant growth will have contributed to:</p> <ul style="list-style-type: none"> the displacement of the bottom stone on the east flanking wall; areas of exposed and eroded footings.

<p>Bottom section of the steps</p>

<p>Example of exposed and eroded footings</p>	<p>Remove the bramble and other invasive plants adjacent to the steps.</p> <p>If and where possible identify, save and /or remove and save well-established ferns</p> <p>With care clean the moss from the steps and low wall without damaging any of the coping stone details and/or tool marks. If in doubt ask.</p> <p>Reveal as much of the stone work as possible to facilitate a detailed assessment of condition.</p> <p>Retain as much of the original fabric as possible and re-bed the flanking wall stones <i>in-situ</i> if possible.</p> <p>Re-bed displaced flanking wall's bottom stone.</p>

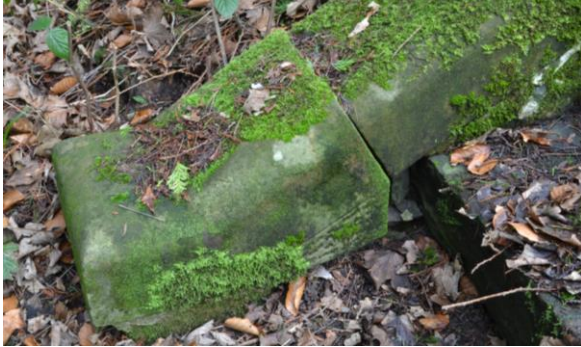
<p>Displaced bottom stone of east flanking wall</p>

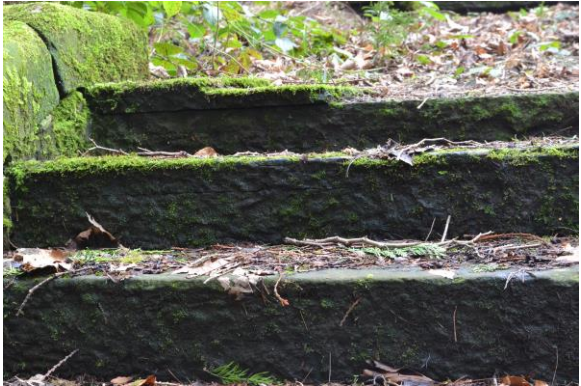
FEATURES	DESCRIPTION & CONDITION	SIG	QUEENS GARDENS SEDBERGH GAZETTEER	RECOMMENDATION	ACTION NOTES
<p>STRUCTURES</p> <p>PROCESSIONAL FLIIGHT OF STEPS TO THE MEMORIAL</p> <p><i>(continued)</i></p> <p><i>Bottom Steps Risers & Treads</i></p>	<p>The treads are showing signs of age and two of them have started to delaminate - the top step is the worst. The bottom step is flaking along the front edge.</p>

<p>Top tread showing delamination</p>

<p>Bottom step showing initial signs of flaking and delamination.</p>	<p>With care clean steps to facilitate full assessment of condition</p> <p>Assess the soundness and health and safety implications of the flaking / delaminated stone. Wherever possible retain original fabric and insert new stone only as required to address any agreed health and safety issues (reversing the stones might prove beneficial in places).</p>

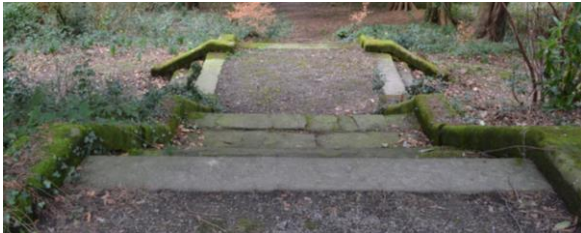
<p>The intersection of the perimeter and axial paths</p>

<p>Five risers on the central path steps</p>	<p>Remove the bramble and other invasive plants adjacent to the steps.</p> <p>With care clean the moss from the steps and low walls without damaging any of the coping stone details and/or tool marks. If in doubt ask.</p> <p>Reveal as much of the stone work as possible to facilitate a detailed assessment of condition.</p>

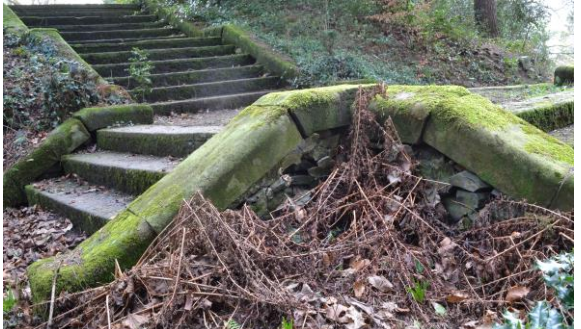
<p>The three risers on the perimeter path steps</p>

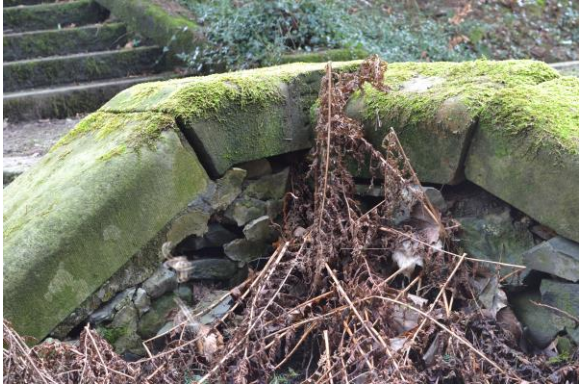
FEATURES	DESCRIPTION & CONDITION	SIG	QUEENS GARDENS SEDBERGH GAZETTEER	RECOMMENDATION	ACTION NOTES
<p>STRUCTURES</p> <p>PROCESSIONAL FLIIGHT OF STEPS TO THE MEMORIAL</p> <p><i>(continued)</i></p> <p><i>Middle Steps Flanking Walls</i></p>	<p>All three sets of N/S steps have the same low flanking walls - and the majority of the dressed stone copings appear to be bedded on exposed rough stone bases which are, in many places, partially eroded, only loosely compacted and structurally unsound.</p> <p>As a result, the individual dressed stone copings are out of alignment and susceptible to damage and loss.</p> <p>At this intersection over half of the bottom stones have been secured effectively, albeit temporarily, by a metal stake driven into the ground to prevent forward movement.</p>

<p>Roughly bedded flanking wall stones at the intersection between the axial path and the west path</p>

<p>Low flanking wall bottom stone retained in place by metal stake</p>	<p>After careful cleaning, record (photograph and mark) all of the flanking wall top stones and store securely whilst supporting wall / new footings are re-built to conservation standard.</p> <p>Re-bed all the top stones.</p>

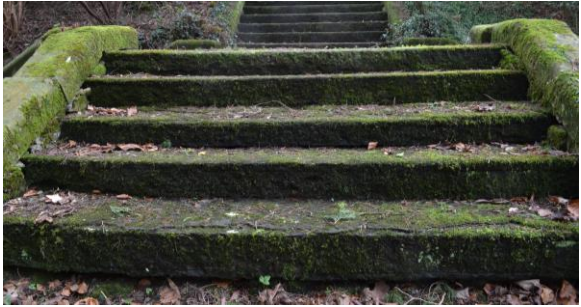
FEATURES	DESCRIPTION & CONDITION	SIG	QUEENS GARDENS SEDBERGH GAZETTEER	RECOMMENDATION	ACTION NOTES
<p>STRUCTURES</p> <p>PROCESSIONAL FLIGHT OF STEPS TO THE MEMORIAL</p> <p><i>(continued)</i></p> <p><i>Middle Steps</i> <i>4 sets of Risers & Treads, meeting at central platform</i></p>	<p>The N/S axial steps / treads: These are in fair condition. The bottom step shows signs of spalling and flaking.</p> <p>The perimeter path east steps /treads: The three steps appear in good condition with no significant signs of spalling or delamination.</p> <p>The perimeter path west steps/treads: The surface of the bottom two steps is starting to fail with some flaking and delaminating.</p>

<p>Axial steps at the intersection</p>

<p>West steps at the intersection with the axial path</p>	<p>With care clean steps to facilitate full assessment of condition.</p> <p>Assess the soundness and health and safety implications of the flaking / delaminated stone. Wherever possible retain original fabric and insert new stone only as required to address any agreed health and safety issues.</p> <p>Protect all the steps throughout the works on the flanking walls.</p>

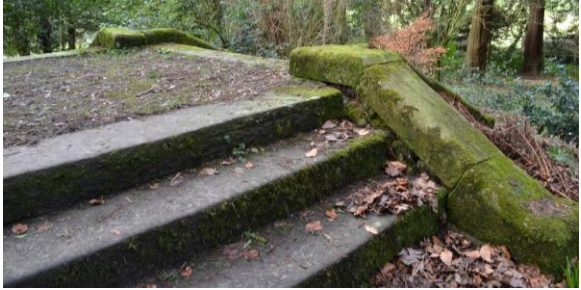
<p>East steps at the intersection with the axial path</p>

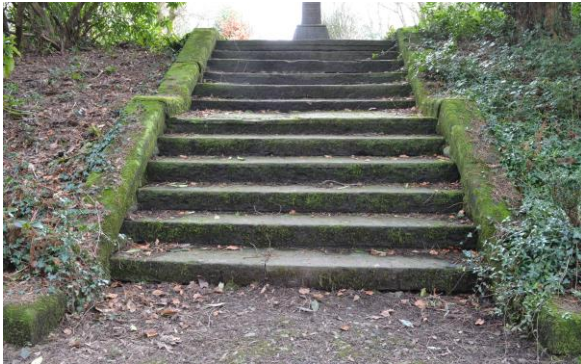
FEATURES	DESCRIPTION & CONDITION	SIG	QUEENS GARDENS SEDBERGH GAZETTEER	RECOMMENDATION	ACTION NOTES
<p>STRUCTURES</p> <p>PROCESSIONAL FLIGHT OF STEPS TO THE MEMORIAL</p> <p><i>(continued)</i></p> <p><i>Top Steps</i></p>	<p>The top section comprises two flights of six risers/treads with a central platform and low flanking walls to the same design as the lower flights.</p> <p>The only difference in design is the central paved stone platform. This comprises two stone slabs & the stone tread of lower steps.</p> <p>The condition of the remainder of the steps and flanking walls is similar to the lower flights.</p>

<p>Top section of steps</p>

<p>Central paved platform</p>	<p>Remove any bramble and other invasive plants adjacent to the steps.</p> <p>With care clean the moss from the steps and low walls without damaging any of the coping stone details and/or tool marks. If in doubt ask.</p> <p>Reveal as much of the stone work as possible to facilitate a detailed assessment of condition.</p>

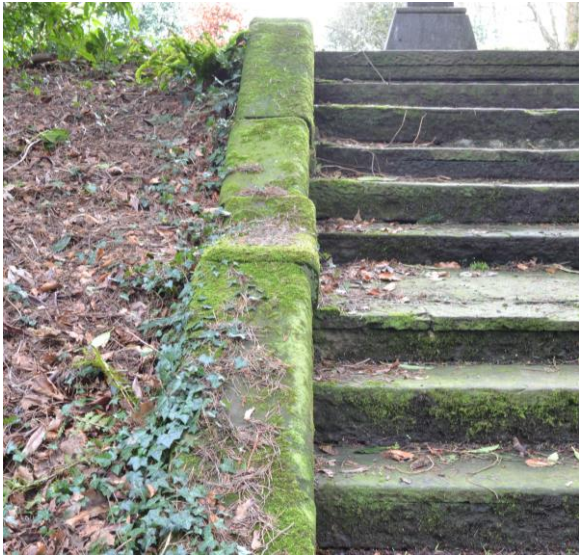
FEATURES	DESCRIPTION & CONDITION	SIG	QUEENS GARDENS SEDBERGH GAZETTEER	RECOMMENDATION	ACTION NOTES
<p>STRUCTURES</p> <p>PROCESSIONAL FLIGHT OF STEPS TO THE MEMORIAL</p> <p>(continued)</p> <p>Top Steps Flanking Walls</p>	<p>As elsewhere on the steps, the flanking coping walls are set on a partially exposed coarse stone base. In parts this remains <i>in situ</i> whilst in others the base has been eroded.</p> <p>As a consequence the copings on the flanking walls have moved although it is not as severe as the movement displayed in the steps' central section.</p>

<p>Top section – settlement on the east flanking wall</p>

<p>Top section – stone base of east flanking wall</p>	<p>After careful cleaning, record (photograph and mark) all of the flanking wall top stones and assess the possibility of renewing / patching the stone base with the coping stones remaining <i>in situ</i>.</p> <p>If not feasible, with care remove and store securely whilst supporting wall / new footings are re-built to conservation standard.</p> <p>Re-bed all the top stones.</p>

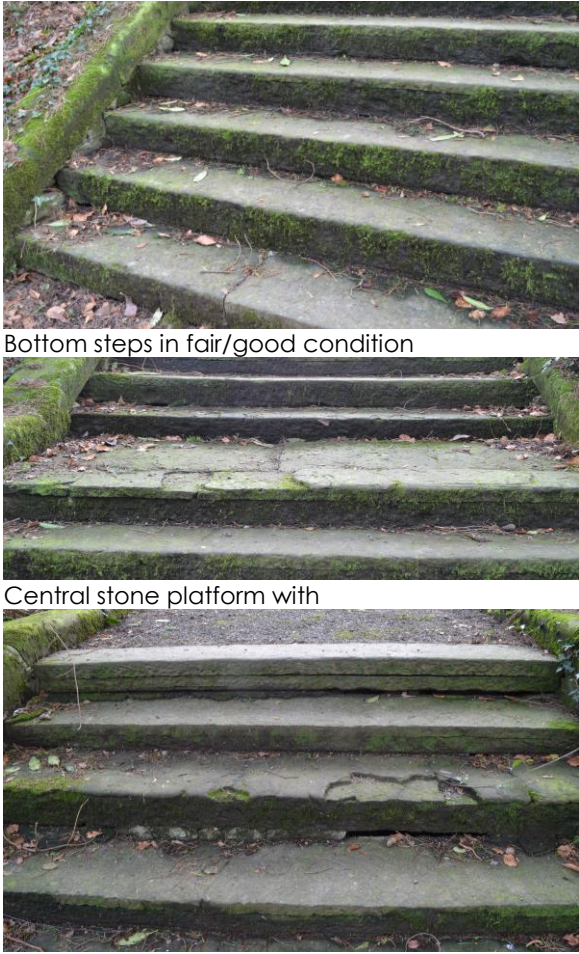
FEATURES	DESCRIPTION & CONDITION	SIG	QUEENS GARDENS SEDBERGH GAZETTEER	RECOMMENDATION	ACTION NOTES
<p>STRUCTURES</p> <p>PROCESSIONAL FLIIGHT OF STEPS TO THE MEMORIAL</p> <p><i>(continued)</i></p> <p><i>Top Steps Risers & Treads</i></p>	<p>The flight of six steps below the stone platform are in fair / good condition with no indication of settlement or significant signs of erosion, flaking or delaminating.</p> <p>The tread that extends to the stone central platform is starting to flake and delaminate.</p> <p>The top steps between the platform and the Celtic Cross are only in fair condition. Gaps are evident between the back of the treads and bottom of the risers – in places these have been filled with mortared stones whose date and provenance is not clear – they do not look recent work.</p> <p>The third from the top tread has in parts delaminated and lost part of its surface.</p>

<p>Bottom steps in fair/good condition</p> <p>Central stone platform with</p> <p>Top steps – showing gap between treads and risers (and small stone infill) and delaminated surface on the tread of the third from top step</p>	<p>With care clean steps to facilitate full assessment of condition.</p> <p>Assess the soundness and health and safety implications of the flaking / delaminated stone on the top section and the landing step.</p> <p>Wherever possible retain original fabric and insert new stone only as required to address any agreed health and safety issues.</p> <p>Protect the all the steps throughout the works on the flanking walls.</p>

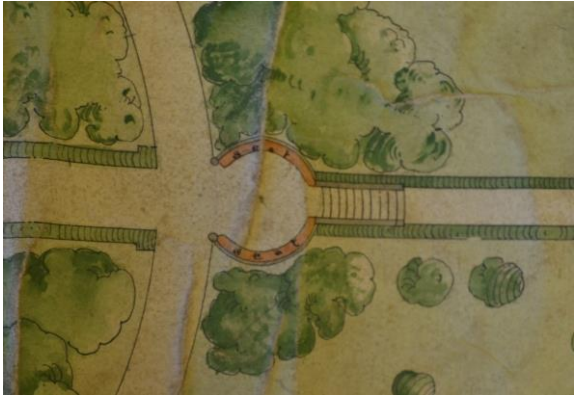
FEATURES	DESCRIPTION & CONDITION	SIG	QUEENS GARDENS SEDBERGH GAZETTEER	RECOMMENDATION	ACTION NOTES
<p>STRUCTURES</p> <p>CIRCULAR LOOKOUT BASTION</p> <p><i>Introduction</i></p>	<p>This feature is located at the south end of the central axial walk and is on the Mawson plan, although with two semi-circular seats. We have not found any evidence that the seats were built.</p> <p>The lookout, from which to survey the wider landscape, was a design device much favoured by Mawson and is a distinctive element in his work. Similar features can be found in the North-West, for example, at Brockhole, where the main terrace terminates in a semi-circular viewing platform overlooking Lake Windermere and a much less well known garden in Grasmere, described, in his book <i>The Art and Craft of Garden Making</i>, as belonging to W. H. Hoyle Esq. A photograph showing the lookout was used to illustrate the Chapter, <i>Rock, Wall & Bog Gardens</i> with the caption 'Rock Garden Merging into the Mountain Side at Grasmere'.</p>	<p>2</p>

<p>Circular lookout shown on Mawson Plan</p>

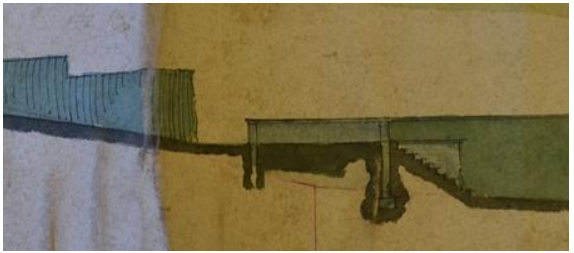
<p>Section of the lookout shown on Mawson Plan</p>

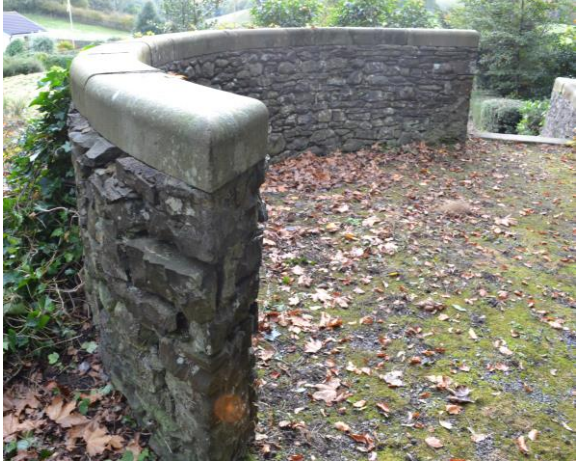
<p>The Circular Lookout - east wall</p>

<p>Coping stone detail at junction between steps and curved walls</p>	<p>This feature is an important, built structure, playing a central – formal – role in the whole composition.</p> <p>The walls should be cleared of ivy & bramble etc., which is undermining the wall in various places. This will assist assessment by conservation engineer. The walls will require extensive rebuilding & advice will inform how this can be done without compromising extant, structurally sound, areas of historic building.</p> <p>Great care must be taken to record & conserve / reinstate some of Mawson's refined details.</p> <p>The immediate setting of the wall must be well-maintained & key views identified / maintained.</p>

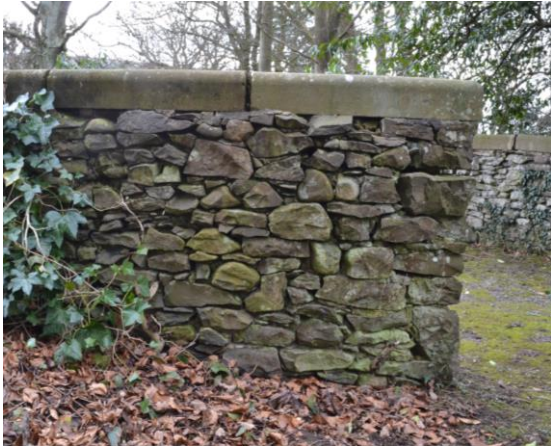
FEATURES	DESCRIPTION & CONDITION	SIG	QUEENS GARDENS SEDBERGH GAZETTEER	RECOMMENDATION	ACTION NOTES
<p>STRUCTURES</p> <p>CIRCULAR LOOKOUT BASTION</p> <p><i>(continued)</i></p> <p><i>The East Wall</i></p>	<p>The structure is still standing, however there are a number of chronic structural issues that are compromising its future including:</p> <ul style="list-style-type: none"> • settlement, bulging and slumping at the east wall's north corner; • bulging structure and loose stones at the wall's north corner and remnants of failed cementitious mortar repairs;

<p>Settlement at north corner of east wall</p>

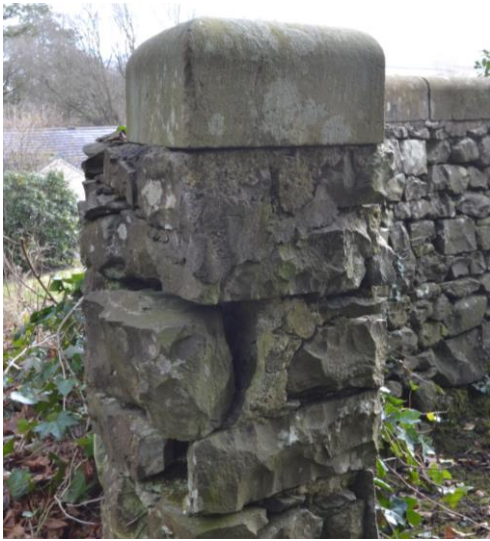
<p>Bulging and loose stones at the north corner</p>

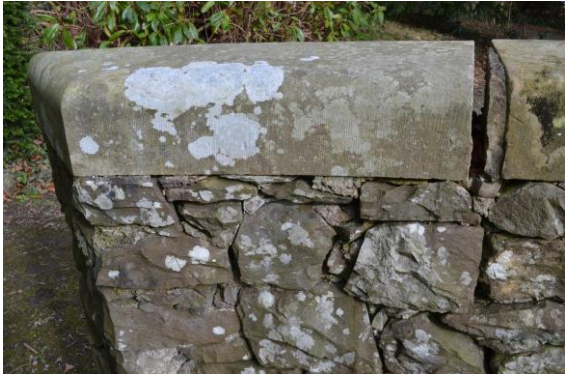
FEATURES	DESCRIPTION & CONDITION	SIG	QUEENS GARDENS SEDBERGH GAZETTEER	RECOMMENDATION	ACTION NOTES
<p>STRUCTURES</p> <p>CIRCULAR LOOKOUT BASTION</p> <p><i>(continued)</i></p> <p><i>The East Wall</i></p>	<ul style="list-style-type: none"> • dropped and misaligned end coping stone caused by settlement and movement of wall; • loss of fabric and compromised structural integrity on outer face of east wall;

<p>Dropped and misaligned end coping</p>

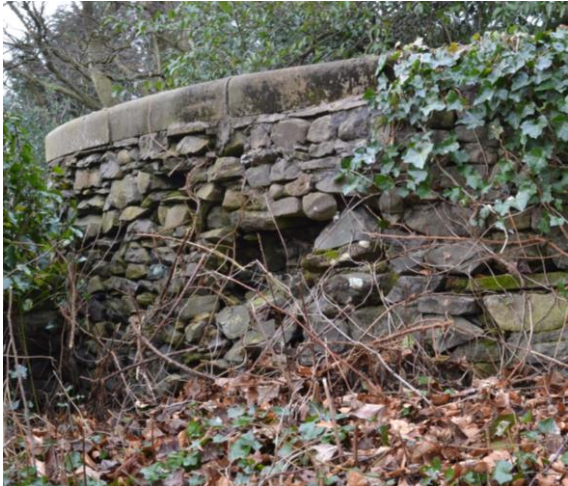
<p>loss of fabric and compromised structural integrity on outer face of east wall</p>

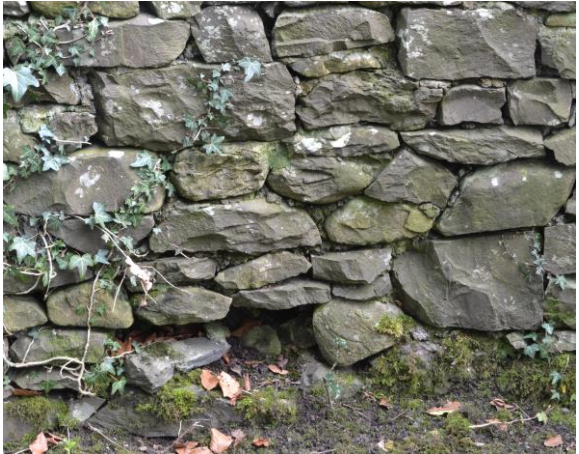
FEATURES	DESCRIPTION & CONDITION	SIG	QUEENS GARDENS SEDBERGH GAZETTEER	RECOMMENDATION	ACTION NOTES
<p>STRUCTURES</p> <p>CIRCULAR LOOKOUT BASTION</p> <p><i>(continued)</i></p> <p><i>The East Wall</i></p>	<ul style="list-style-type: none"> loss of fabric and compromised structural integrity at the base of the inner face of east wall; split, partially patched and mis-aligned coping re-bedded at some time on cement mortar.

<p>loss of fabric on the inner face of east wall</p>

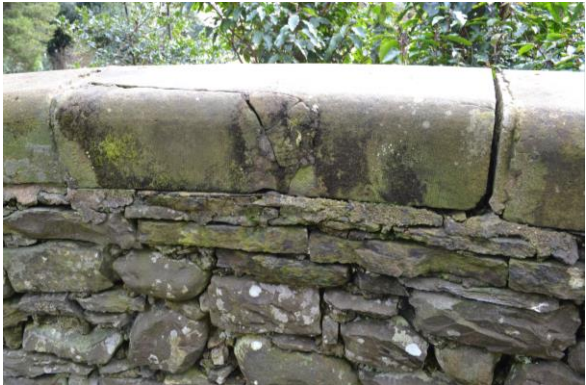
<p>Split and misaligned coping on east wall</p>

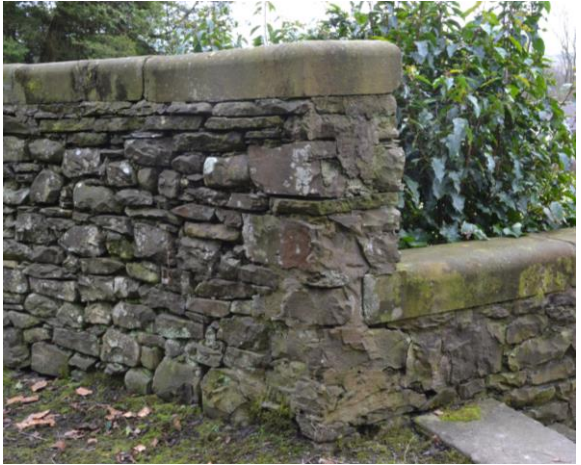
FEATURES	DESCRIPTION & CONDITION	SIG	QUEENS GARDENS SEDBERGH GAZETTEER	RECOMMENDATION	ACTION NOTES
<p>STRUCTURES</p> <p>CIRCULAR LOOKOUT BASTION</p> <p><i>(continued)</i></p> <p><i>The East Wall</i></p>	<p>Areas of cementitious mortar have been applied over the years to the dry-stone wall facing; however it is particularly striking and inappropriate on the east wall's south corner - the comparison with Mawson's sensitive coping stone detail is telling</p>

<p>Cementitious mortar applied to the face of the east wall's south corner</p>

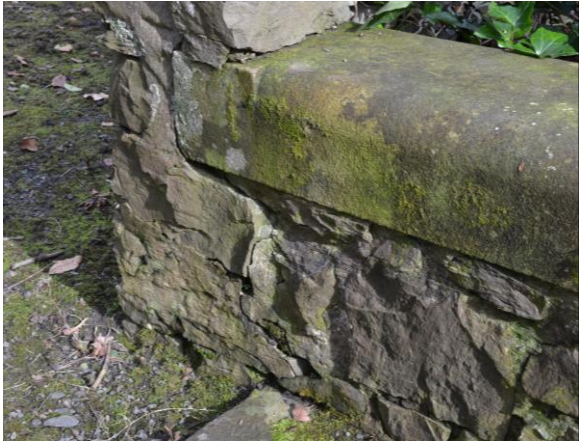
<p>Mawson's coping detail adjacent to areas of applied cementitious mortar</p>

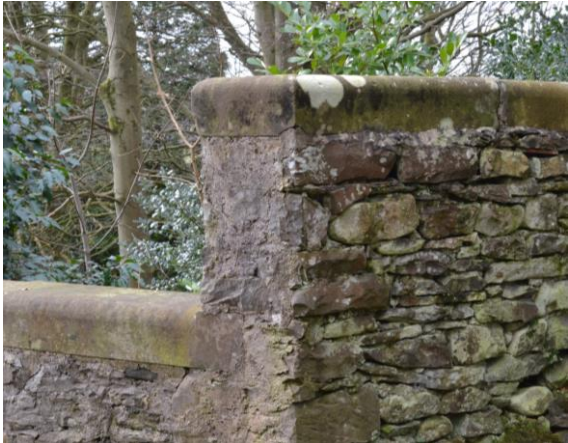
FEATURES	DESCRIPTION & CONDITION	SIG	QUEENS GARDENS SEDBERGH GAZETTEER	RECOMMENDATION	ACTION NOTES
<p>STRUCTURES</p> <p>CIRCULAR LOOKOUT BASTION</p> <p><i>(continued)</i></p> <p><i>The West Wall</i></p>	<p>The curved west wall is, if anything, in poorer condition than the east. Points of concern include:</p> <ul style="list-style-type: none"> • cementitious mortar / render that covers virtually the whole of the end face at the south of the west wall; • areas of inner face with missing and loosely fitting stones;

<p>End face with applied mortar / render</p>

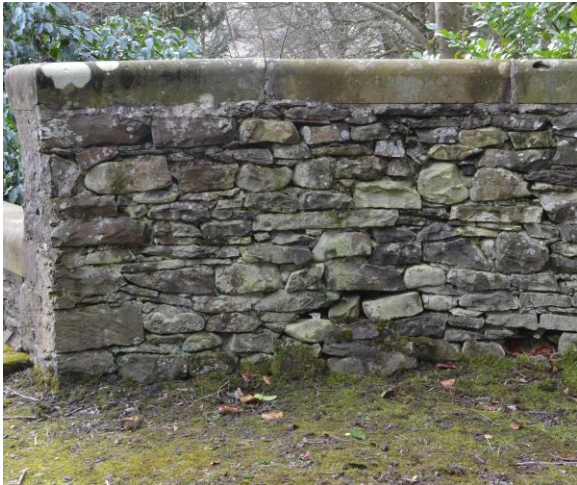
<p>Inner face of west wall with areas of missing stone</p>

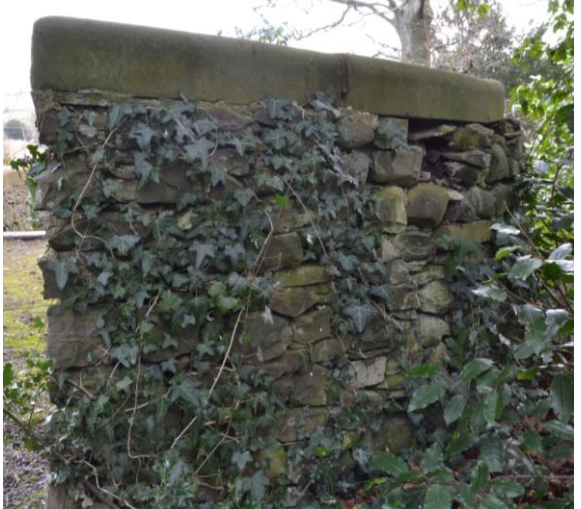
FEATURES	DESCRIPTION & CONDITION	SIG	QUEENS GARDENS SEDBERGH GAZETTEER	RECOMMENDATION	ACTION NOTES
<p>STRUCTURES</p> <p>CIRCULAR LOOKOUT BASTION</p> <p><i>(continued)</i></p> <p><i>The West Wall</i></p>	<ul style="list-style-type: none"> • loss of fabric and compromised structural integrity on outer face of the west wall; • loss of stones running through the width of the wall and contributing to the wall's increasing lack of stability;

<p>Loss of fabric and compromised structural integrity on outer face of west wall</p>

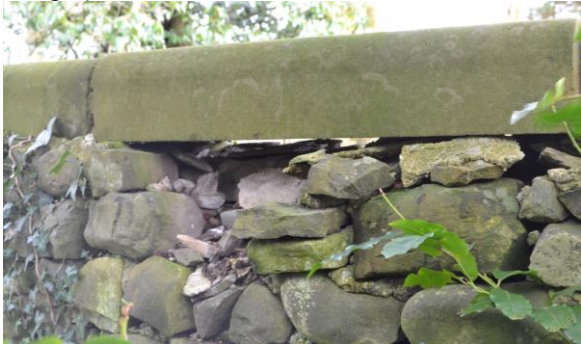
<p>Missing stones contribute to the increasingly unstable condition of the wall</p>

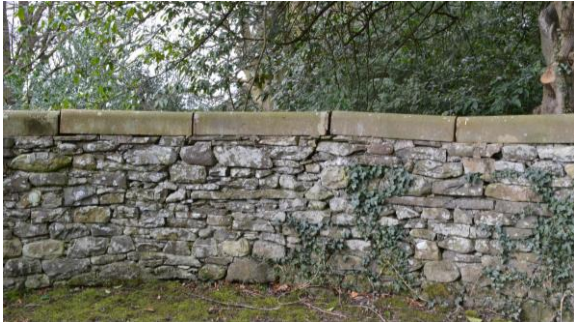
FEATURES	DESCRIPTION & CONDITION	SIG	QUEENS GARDENS SEDBERGH GAZETTEER	RECOMMENDATION	ACTION NOTES
<p>STRUCTURES</p> <p>CIRCULAR LOOKOUT BASTION</p> <p><i>(continued)</i></p> <p><i>The West Wall</i></p>	<ul style="list-style-type: none"> the uneven settlement of the wall and the loss of structural fabric and integrity is evidence of the unevenly bedded and un-aligned copings; outer face of the west wall temporarily patched with ill-fitting stones – in parts stones have been augmented with other materials – see below;

<p>Poorly bedded and un-aligned coping stones on the west wall</p>

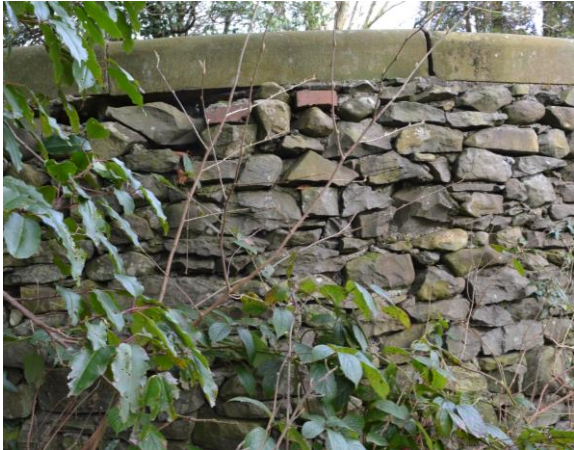
<p>Temporary repairs on the outer face of the west wall</p>

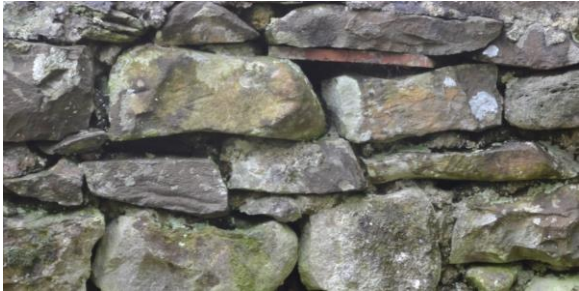
FEATURES	DESCRIPTION & CONDITION	SIG	QUEENS GARDENS SEDBERGH GAZETTEER	RECOMMENDATION	ACTION NOTES
<p>STRUCTURES</p> <p>CIRCULAR LOOKOUT BASTION</p> <p><i>(continued)</i></p> <p><i>The West Wall</i></p>	<ul style="list-style-type: none"> the different (and sometimes inappropriate) materials used to patch and repair the wall including what appears to be a quarry tile, broken pre-cast concrete pavers and pieces of broken brick.

<p>West wall inner face patched with quarry tile</p>

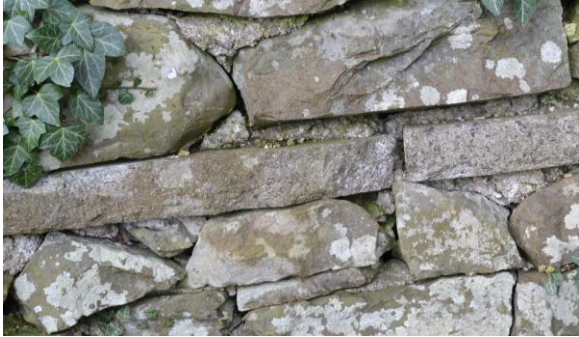
<p>West wall patched with broken pre-cast concrete pavers</p>

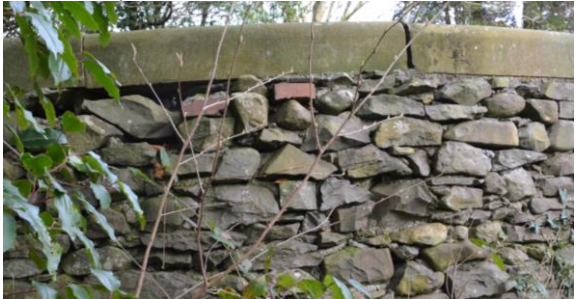
<p>West wall patched with broken pieces of brick</p>

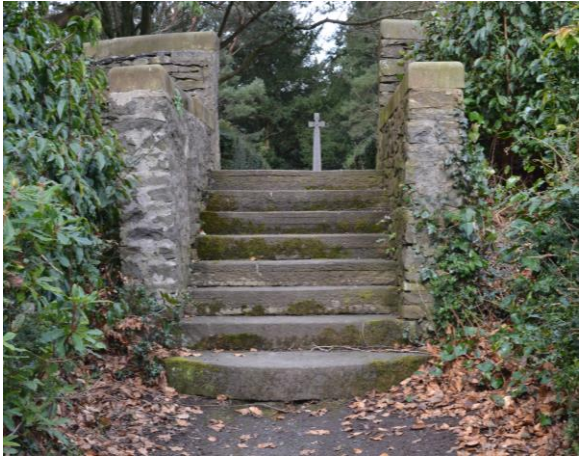
FEATURES	DESCRIPTION & CONDITION	SIG	QUEENS GARDENS SEDBERGH GAZETTEER	RECOMMENDATION	ACTION NOTES
<p>STRUCTURES</p> <p>CIRCULAR LOOKOUT BASTION - FLIGHT OF STEPS</p> <p><i>Introduction</i></p>	<p>The steps are shown on the Mawson plan (see above). The stone steps comprise eight risers and are flanked on both sides by rough stone walls capped with dressed stone copings similar to those used on the circular lookout structure.</p> <p>Again, the feature has the strong and robust character that is associated with Thomas Mawson's public and private commissions.</p> <p>The step treads show some signs of use however they appear to be well bedded and in good condition with little evidence of the stone delaminating.</p> <p>Both the flanking walls appear to be leaning outwards although the west wall (left on the photograph) is the most out of true. This seems to have been acknowledged by the heavy repointing and general application of cementitious mortar – refer to photograph on following page.</p> <p>There is no handrail and there no indication that one was ever installed.</p>	<p>2</p>

<p>Steps to the south of the Circular Lookout – note the lean on the flanking walls</p>

<p>Detail of stone steps</p>	<p>The walls should be cleared of ivy & bramble etc., which is undermining the wall in various places. This will assist assessment by conservation engineer. The walls will require extensive rebuilding & advice will inform how this can be done without compromising extant, structurally sound, areas of historic building.</p> <p>Great care must be taken to record & conserve / reinstate some of Mawson's refined details.</p>	<p>Commission Conservation Engineer https://www.istructe.org/about-us/organisation-structure/subsidiary-organisations/conservation-accreditation-register-for-engineers</p> <p>Contact Dry Stone Walling Association http://www.dswa.org.uk/</p> <p>Locally, Cumbria's Drystone walling Association - www.dswa.org.uk/cumbria.asp</p>

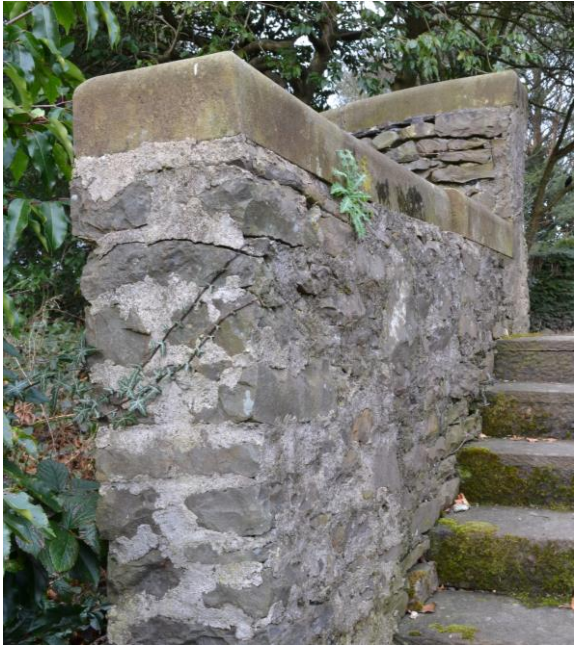
<p>Detail of the repairs on the west flanking wall</p>

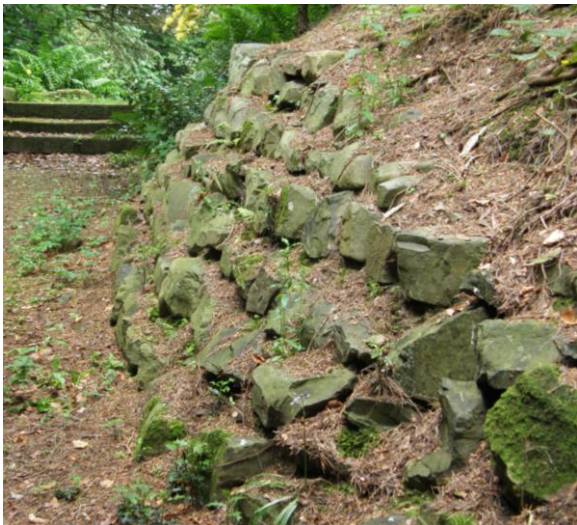
FEATURES	DESCRIPTION & CONDITION	SIG	QUEENS GARDENS SEDBERGH GAZETTEER	RECOMMENDATION	ACTION NOTES
<p>STRUCTURES</p> <p>RETAINING & ORNAMENTAL ROCKWORK</p> <p><i>Introduction</i></p>	<p>The perimeter path that runs at the base of the memorial knoll is cut into the bank which, in parts, is faced with rockwork. This is particularly distinctive to the west of central path. The photograph shows the rockwork providing stability to the slope and planting opportunities.</p> <p>To the east of the central path the slopes are less steep and inevitably the rock work is less striking.</p> <p>Both areas of rockworks are shown on early (1903) photographs and, notwithstanding the spread of undergrowth, it is important to note that much of Mawson's original structural work is extant.</p>	<p>2</p>

<p>Retaining rockwork on the bank to the west of the central path</p>

<p>Careful clearing of invasive vegetation – including some of ivy and any bramble – will help to reveal how much is intact & what requires repair. Note that, to build a rockery with such a steep profile is a major undertaking - the degree of survival is a reflection of excellence of infrastructure; <u>no</u> careless weeding / cutting / cleaning, which might cause further damage & destabilise banks.</p> <p>Evidence that original planting included rhododendrons & azaleas. Remove/cut these back (if they have become too large), to improve management, <u>only</u> after monitoring for 1-2 years, to ascertain whether these are flowering, to inform identification.</p> <p>Take care not to dislodge any of shrubs / trees on top of banks.</p>	<p>Advice from Conservation Engineer would be useful.</p>

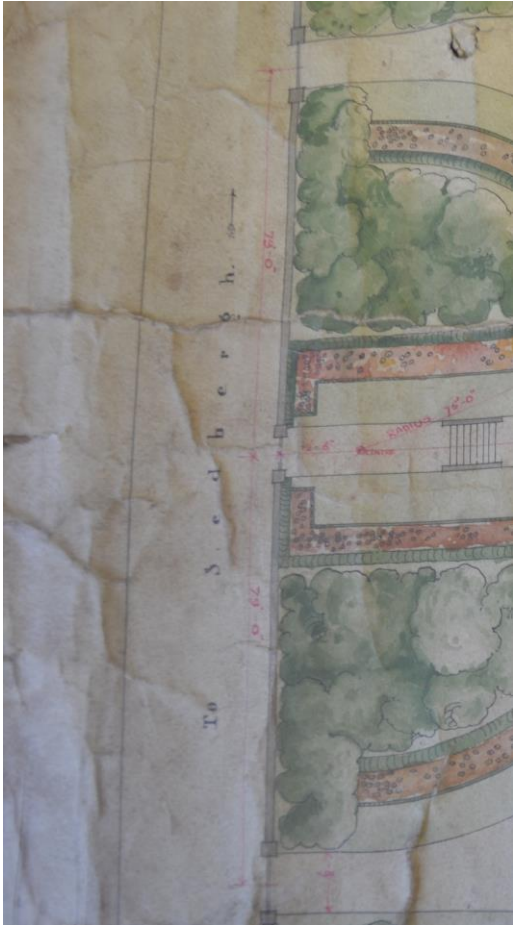
<p>Mawson plan showing close relationship between the Gardens' boundary and the road.</p>	<p>The impossibility of using the proper entrance gates along the northern front of the Gardens is a major problem. It does more than anything else to undermine both the accessibility of the Gardens & the way in which the visitor was intended to experience a walk through the Gardens.</p> <p>Ultimately, the only satisfactory answer is to build a footpath &/or to have a zebra crossing, leading to the central gate. To do this by setting the original wall back – which is an inventive idea & may be a last resort – would do damage to the Mawson wall & his planting.</p>	<p>Discuss with Highways how this problem might be addressed, especially in light of field opposite being designated for residential building in the Local Plan.</p>

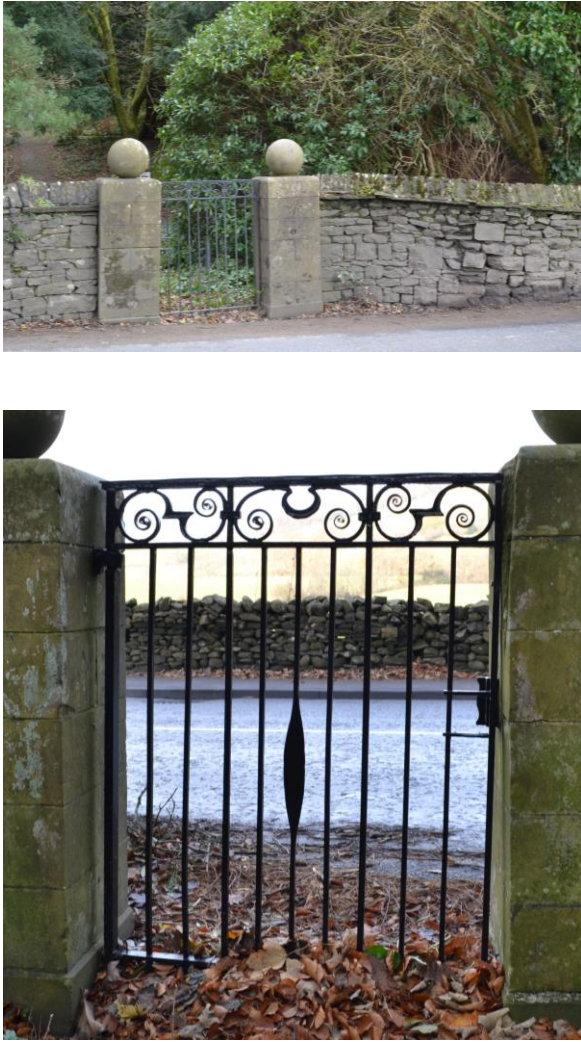
FEATURES	DESCRIPTION & CONDITION	SIG	QUEENS GARDENS SEDBERGH GAZETTEER	RECOMMENDATION	ACTION NOTES
<p>BOUNDARIES</p> <p>NORTH BOUNDARY</p> <p><i>(continued)</i></p> <p>Side Entrances</p>	<p>The north boundary's principal gate is flanked on either side by two, more modest, secondary gates, which, if they were open would provide access to the perimeter path – but like the principal gate they are fastened shut to stop direct access on to the A648 carriageway.</p> <p>Both entrances have five course sandstone ashlar piers finished with a simple ball finial set on a coping stone with mitred corners (the latter a design detail used throughout the Gardens, as on flanking wall to the central steps).</p> <p>The gate is delightfully crafted using wrought iron techniques to flatten and rotate the detail on the central vertical bar and the top ornamental band, which has something of the quality of the Celtic cross's carved strap work and foliate decoration.</p> <p>We understand that the wrought iron gate was removed and repainted in 2016.</p>

<p>We note that, when repaired / restored, the side gate on the NW corner was rehung so that it does not quite shut.</p> <p>When the gate is next painted / repaired - & assuming the stone piers do not need to be rebuilt – this gate should be modified, so that it fits properly, without damaging the pier.</p>

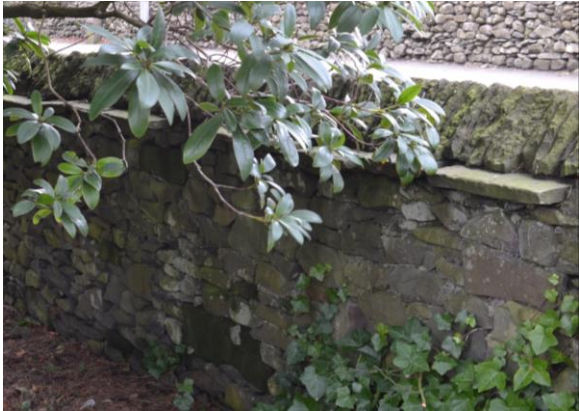
FEATURES	DESCRIPTION & CONDITION	SIG	QUEENS GARDENS SEDBERGH GAZETTEER	RECOMMENDATION	ACTION NOTES
<p>BOUNDARIES</p> <p>NORTH BOUNDARY</p> <p><i>(continued)</i></p> <p><i>The Wall</i></p>	<p>The north boundary dry stone wall is distinguished by projecting flat stone course topped by a triangular coping.</p> <p>This feature is very typical of Mawson's work, as he championed the use of the vernacular wherever possible:</p> <p>"A well-constructed dry wall is always pleasing and each district has its own mode of building to suit the character of the local stone, whether quarried stone slate, cobbles, rubble or flints or a combination of any of these, with or without bricks or tiles."⁷</p> <p>Mawson illustrates this with a number of drawings showing slates or tiles used as a projecting bedding course for copings – a device also illustrated with photographs of a wall and entrance at the Mawson designed garden, Above Beck, north of Grassmere village.</p> <p>The wall and entrance at Above Beck are extant, in good condition and visible from the public road just north of the Kendal / Keswick Road (A591), although the gardens are not open to the public.</p>

<p>Distinctive top course comprising projecting horizontal course capped with triangular coping</p>

<p>Mawson's entrance wall, Above Beck, Grassmere</p>	<p>The walls are in generally good condition. There are areas, however, where there is a heavy cover of ivy & this is threatening the stability of the wall in some places.</p> <p>Ensure than any on-going repairs echo the character & quality of the original wall.</p>

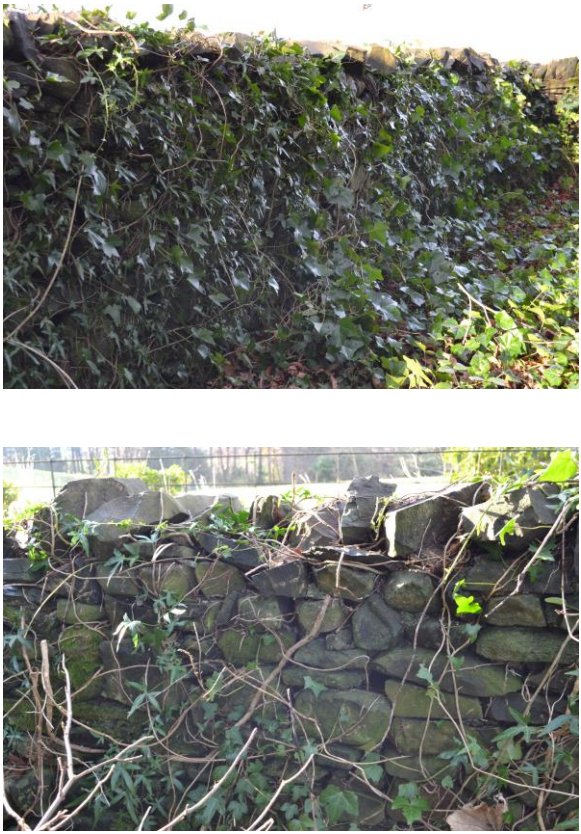
FEATURES	DESCRIPTION & CONDITION	SIG	QUEENS GARDENS SEDBERGH GAZETTEER	RECOMMENDATION	ACTION NOTES
<p>BOUNDARIES</p> <p>WEST, EAST & SOUTH BOUNDARY</p> <p><i>Introduction</i></p> <p><i>The Walls</i></p>	<p>The east and west boundaries are marked by dry stone walls. To the east the Gardens are set against houses and gardens on Queen's Drive and to the west the boundary is shared with the grounds of Randall Hill.</p> <p>At the moment it is difficult to assess the walls' condition, as much is covered by heavy growths of ivy and/or dense shrub/tree regeneration. This obviously makes a management regime of monitoring and repairing difficult to maintain.</p> <p>In places where the walls were accessible it was noted the dry stone construction had not been augmented with surface applications of mortar – the original character remains substantially intact.</p> <p>It was also noted, however, that, in many places, there was not an effective coping course, as there is on the north boundary. Even in dry wall construction, the coping course serves to restrict water ingress and re-inforce / conserve the integrity of the structure</p> <p>The south boundary (rebuilt further south, after addition of Bowling Green, in 1909/10) runs against fields and the well maintained dry stone wall is an appropriate and efficient boundary.</p>	<p>3</p>

<p>It is essential that access to the walls should be secured and maintained. Keeping these in good condition is a necessary task & will require regular revisiting.</p> <p>With care, any lengths of wall which might be original (if it can be ascertained, perhaps by examining the wall on the outer, western side, for example), should be carefully documented (photographed & drawn, as required). In particular, if there is a distinctive style of walling, this should be recorded.</p> <p>The whole wall should be surveyed, to identify areas which require repair / rebuild. Ensure coping stones are employed.</p>	<p>Contact Dry Stone Walling Association for any necessary advice, or to undertake survey, or to discuss whether wall repairs / rebuilding might offer opportunities for apprentices / volunteers.</p> <p>http://www.dswa.org.uk/</p> <p>Locally, Cumbria's Drystone walling Association - www.dswa.org.uk/cumbria.asp</p>

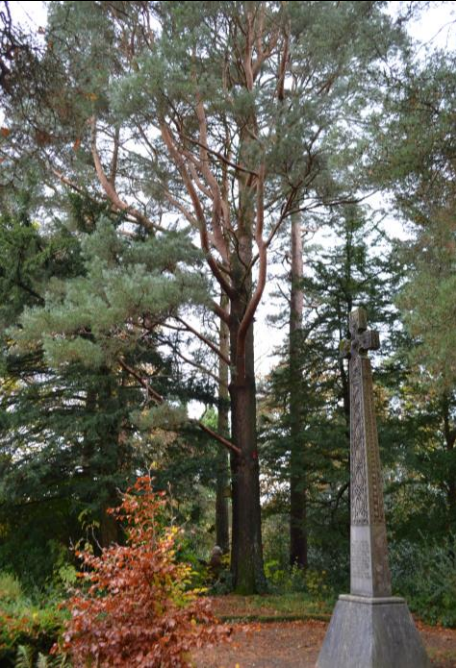
<p>Scots pines with cross & fern leafed beech adjacent – statuesque & symbolic.</p>

<p>Interpret dramatic narrative articulated by these plantings.</p> <p>Sheer range of plants also deserves to be explored & promoted.</p> <p>Monitor & manage designed groups of trees, including entrance conifers, Scots pines around cross & fern leafed beech, especially after storm events. Ensure scrub growth around the trees does not become too vigorous.</p>

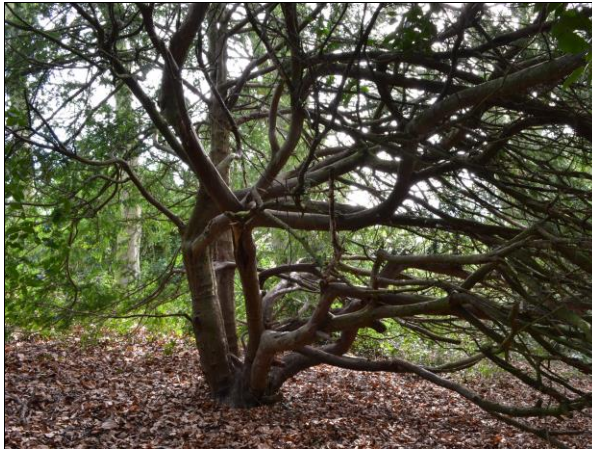
<p>Yew, with spreading branches & little leaf, showing results of lack of light.</p>

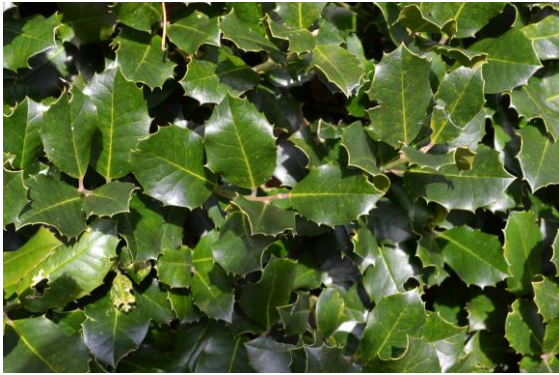
<p>?<i>Ilex x altaclarensis</i> 'Hodginsii' This cultivar rasied in early 1800s.</p>	<p>Assess condition and take all evergreens. Selectively and over time reduce &/or undertake formative pruning to better specimens. If plants appear self-seeded, too crowded or are too poor to flourish, remove.</p> <p>Use these plants to provide suitable backdrops / setting / frames for structural motifs – steps & lookout bastion, for example – and for views & more floriferous planting.</p> <p>Over time, study hollies in Gardens & try & identify different forms. New plantings should reflect this variety. Note that, if too dark or etiolated, plant growth is poor - & it is very hard to discern different varieties.</p>	<p>Consider arranging visits to National collection of holly – RHS Garden, Rosemoor, Devon, to aid identification & inform future planting plans.</p> <p>https://www.rhs.org.uk/plants/plantmanship/national-plant-collections/comus/ilex</p>

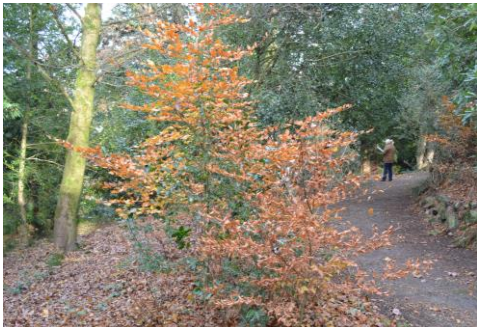
<p>One of many groups of self-seeded beeches.</p>	<p>Extensive tree works are necessary. Some work will be pruning, reshaping etc., as described above, but there will also be a need for considerable thinning-out, if existing mature trees and desirable juvenile ones are to thrive. Some of the work will also be required after a proper Health & Safety survey of the trees.</p> <p>If these works are undertaken over one or two winter seasons, thought should be given to clearing areas suitable for replanting. As noted, there are several good saplings of self-seeded beech which can be singled out, grown on and used <i>in situ</i> or transplanted, as desired.</p>	<p>Initiate public consultation / information about need for tree works.</p>
