FEATURES	DESCRIPTION & CONDITION	SIG	QUEENS GARDENS SEDBERGH GAZETTEER	RECOMMENDATION	ACTION NOTES
<p>STRUCTURES</p> <p>QUEEN VICTORIA MEMORIAL: SETTING & SENTIMENT</p>	<p>It is not unusual to find a statue or other memorial to Queen Victoria in the nation's public spaces, and buildings, parks, cathedrals and churches. For example, there are ten substantial statues of Victoria in the North-west of England alone¹.</p> <p>It is unusual that this memorial, its sentiment & setting, were conceived, designed & constructed at the same time - an opportunity which Mrs. Florence Anne Upton-Cottrell-Dormer and Thomas Mawson exploited to great effect, to create dramatic landscape theatre (albeit one that the instigator could never have seen reach maturity²). This composition remains substantially intact.</p> <p>The superbly-carved cross, some sixteen feet tall, stands on the highest point of the site and is approached from the principal entrance, through the 'dark vale', before ascending via the broad processional steps to the memorial bathed in light.</p> <p>It is for these reasons that we consider the extant memorial and its designed setting to be of major significance.</p>	<p>1</p>

FEATURE

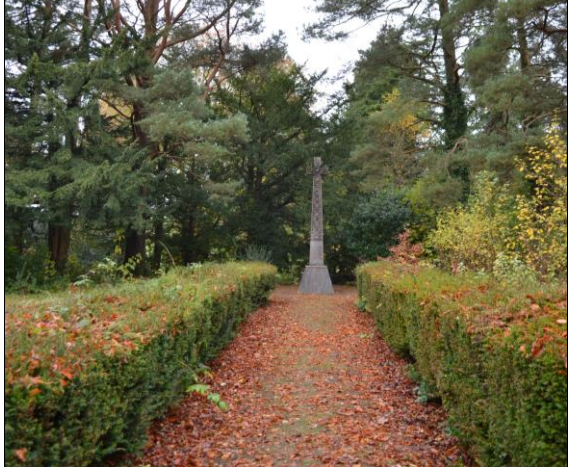
<p>Yew hedges in Nov: broad top – vulnerable to damage</p>	<p>Good rhododendrons & azaleas, well-managed, would have been planted in number. Likewise, formal, well-trimmed, yew hedges were vital, to help articulate distinction between formal / informal. Replanting / reinstating / formative pruning & management necessary.</p> <p>Plant groups of rhododendrons (not singly) along front of tree groups (but with access to light). Also along the N. margin of the Gardens, as visible signal that here are ornamental public Gardens. If desired, select forms listed by Mawson (add this to interpretation).</p> <p>Over 2-3 years, hard prune hedge to create taller, thicker, battered profile. Feed & water.</p>	<p>Over a season, record & compile list of all flowering <i>Rhododendron</i> in Gardens (avoid cutting back any more rhodos. in gardens until this survey complete).</p> <p>Advice & assistance in identifying, see <i>Rhododendron Society UK</i>, http://www.rhodogroup-rhs.org/</p>

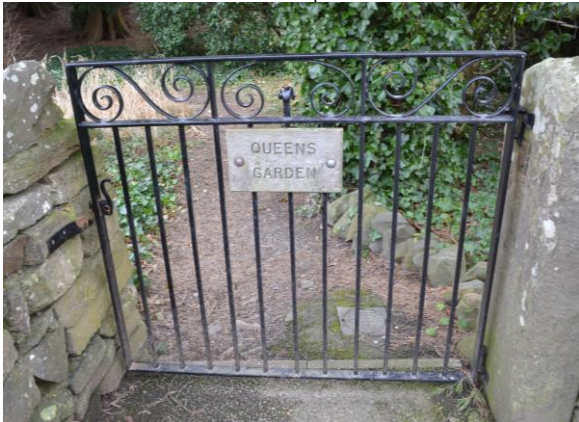
<p>New (and only) access from the main road.</p>	<p>The entrance sign is suitably modest – but it might be designed to do more to signify the quality of the Gardens beyond the gate.</p> <p>Maintain the entrance sign.</p> <p>The dry-stone wall into which the gate has been inserted and where the latch now sits, should be monitored and repaired as required.</p>	<p>Discuss with Highways how access problem might be addressed, especially in light of field opposite being designated for residential building in the Local Plan.</p> <p>Also discuss whether some relocation of highway signs – so they do not obscure Gardens – might be possible.</p>

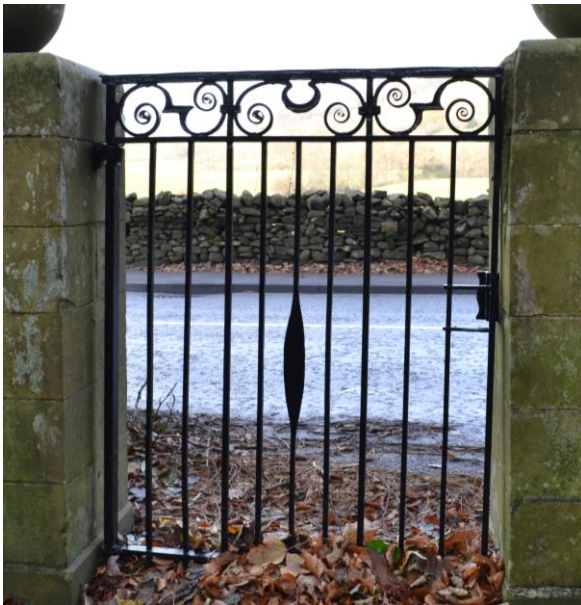
<p>Historic arts and crafts wrought iron gate</p>

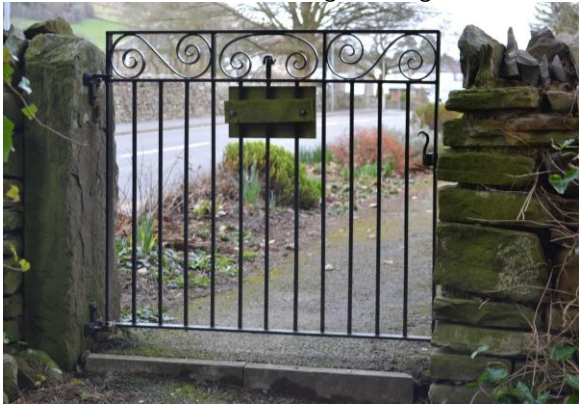
<p>New gate using the historic gate as a pattern</p>

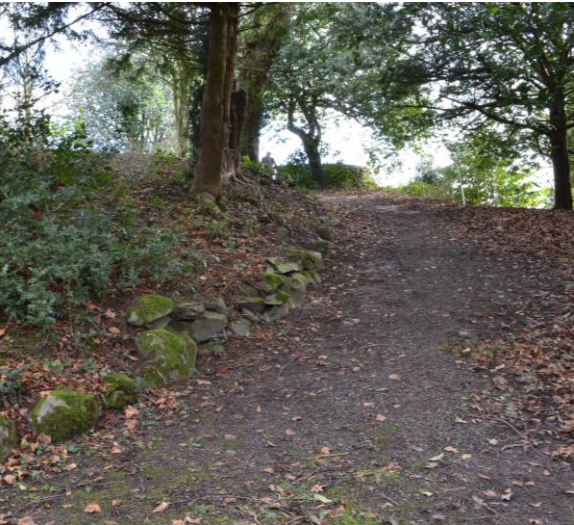
<p>Broad sweeping lines at the intersections of walks</p> </div>	<p>Note that junctions between paths are very important to the quality of the designed Gardens. They require informed management, to ensure that the edges do not get lost beneath vegetation, eroded, etc.</p> <p>Prepare simple plan of Gardens, highlighting key junctions, so maintenance is straightforward.</p> <p>In addition to maintaining junctions as designed, ensure surfaces of footpaths are well-maintained.</p>

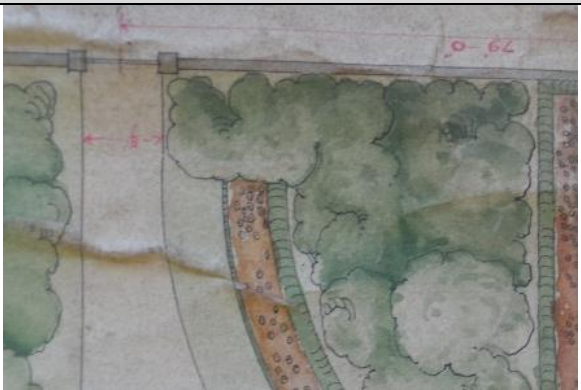
<p>West path dimensioned at 8'</p>

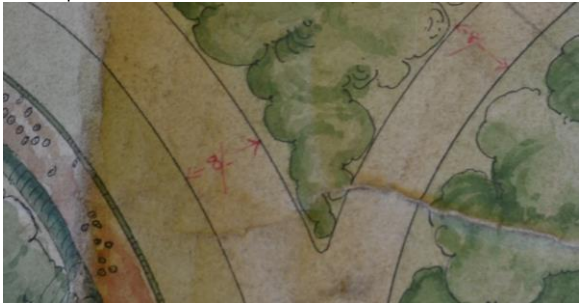
<p>Perimeter paths dimensioned at 8'</p>

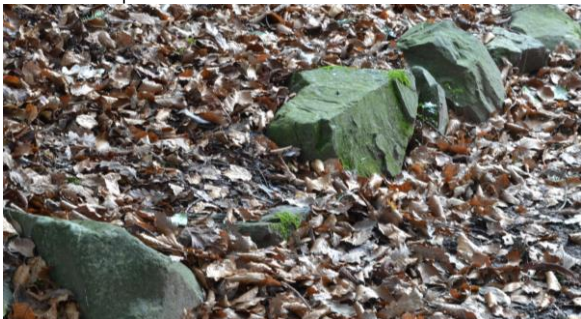
<p>Edging stones at the base of the knoll</p>	<p>Refine & maintain all the edges of the paths - including revealing / reinstating stone edging, especially where the adjacent ground is banked or where there are forks in the path. Making these small changes will enormously enhance the accessibility and the inviting quality of the paths.</p> <p>It is important to recover the sense that the central and highest N/S path – between cross and lookout – is the most important in the Gardens. Improvements may be made by reshaping - by degrees - the yew hedge, to minimise its overhang onto the path.</p>

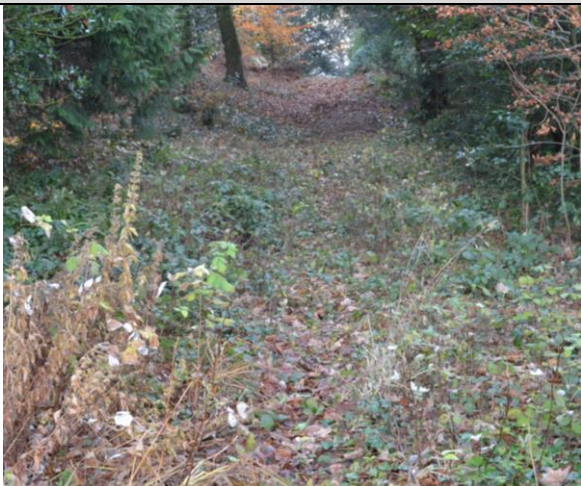
FEATURES	DESCRIPTION & CONDITION	SIG	QUEENS GARDENS SEDBERGH GAZETTEER	RECOMMENDATION	ACTION NOTES
<p>ACCESS & CIRCULATION</p> <p>(continued)</p> <p>MORIBUND PATHS</p> <p>The west path to and from the closed gate</p>	<p>The enforced closure of the three gates on the North boundary (see above) has inevitably had a major impact on the circulation within the Gardens - the two arms of the perimeter path that led to and from the entrances are now obviously barely used. They are now what Mawson would call, "stop-end walks", about which he cautions in <i>The Art & Craft of Garden Making</i>:</p> <p>"To be compelled to return by the same route is undesirable, therefore stop-end walks should only be made when there are strong reasons for so doing, as when leading to a particularly pleasing view, a rocky eminence for instance, ascended by solid hewn steps, or a rounded knoll surmounted by a patriarchal tree, and so forth."¹⁰</p> <p>The path to the shut NW gate is now little used - it has lost its formal garden character and is being overwhelmed by scrub growth.</p>

<p>View of the overgrown path from the west gate</p>

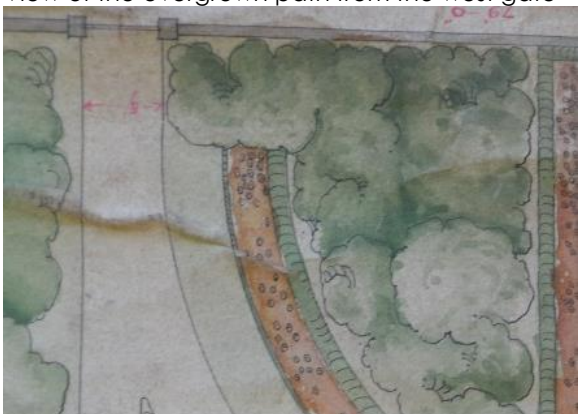
<p>Eight foot wide path to the west gate as drawn and constructed by Mawson</p>	<p>Consider introducing a new W/E path close to the northern boundary. We suggest that this might be south of the first two <i>Thuja plicata</i>, rather than hard against the wall, as this would allow the retention of the thuyas close to the wall. It would necessitate constructing the path so that there would be minimal digging within the Root Protection Areas (RPA) of the thuyas. Lifting the canopies of the thuyas (mostly by removing dead wood) and removing the Douglas fir and a good holly would be required. But this would recreate a circular walk, lend some function to the path on the NW in particular, and allow visitors to enter from the NE side & still approach the steps & cross as intended. See Masterplan.</p>

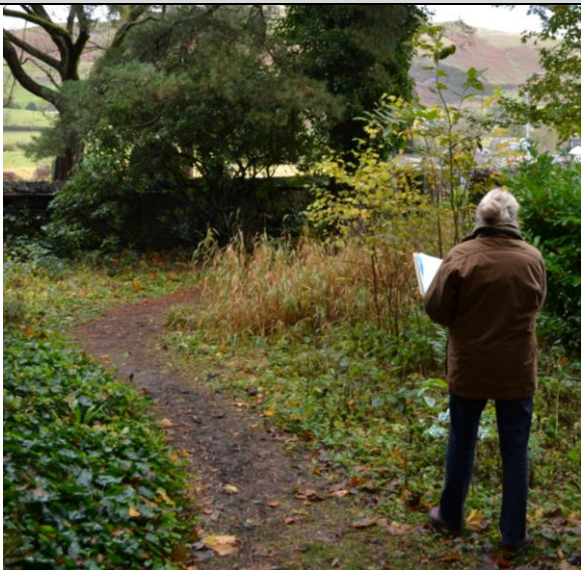
FEATURES	DESCRIPTION & CONDITION	SIG	QUEENS GARDENS SEDBERGH GAZETTEER	RECOMMENDATION	ACTION NOTES
<p>ACCESS & CIRCULATION</p> <p><i>(continued)</i></p> <p>MORIBUND PATHS</p> <p><i>The east path to and from the closed gate</i></p>	<p>The historic circulation to and from the NE gate has also been compromised by the permanent gate closure and the <i>ad hoc</i> path to and from the new safe entrance.</p> <p>The visual impact, however, on historic path layout is much less noticeable when the path is viewed through the east gate and the view much less compromised than that offered by the overgrown path at the west gate.</p>

<p>New ad hoc path to new safe entrance</p>

<p>Historic path layout viewed through east gate</p>	<p>Refining and confirming the route and character of the new path already giving access into the Gardens from the NE would form part of the modification / introduction of paths described above. Rough, informal paths – especially at the entrance – contradict the character of these Gardens.</p>

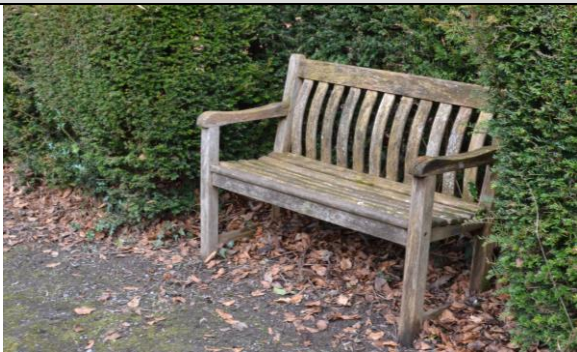
<p>Bench in the yew hedge bay on the axial walk</p>

<p>Benches looking over towards Holme Knott</p>	<p>All locations designed for seats - round the cross & on principal N/S walk - should have new benches: timber benches, of substantial weight & character. All renewals (including memorial benches) in same style.</p> <p>In key places, where views are obtainable, new benches could be introduced, but never in <i>ad hoc</i> fashion. Any new benches - along the paths for example - should be located in well-designed recesses, constructed adjacent to, and not on, the line of the paths.</p> <p>Consider whether SE corner of the Gardens, which once accommodated shelter / bandstand, might be modified so that new seats could be laid out here to command outstanding views, & a simple shelter or similar, might be introduced to accommodate small events.</p>

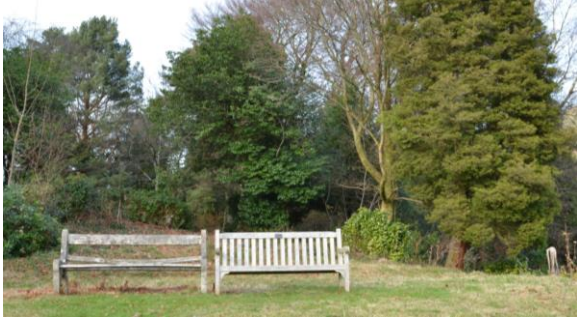
<p>Benches to south east of circular lookout</p>

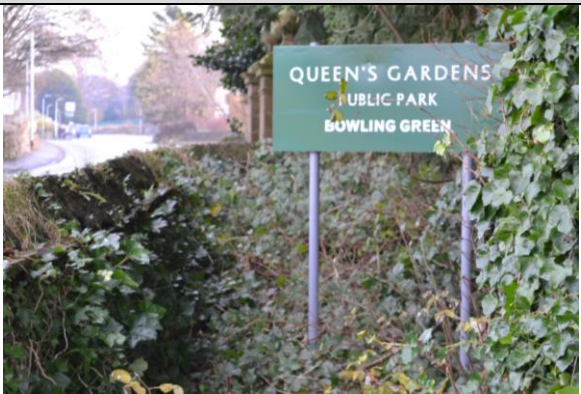
FEATURES	DESCRIPTION & CONDITION	SIG	QUEENS GARDENS SEDBERGH GAZETTEER	RECOMMENDATION	ACTION NOTES
<p>FURNITURE & SIGNAGE</p> <p><i>(continued)</i></p> <p>SIGNAGE</p>	<p>The signage for the Gardens is modest and comprises two signs placed inside the north wall adjacent to the east and west gates. Both are relatively small, tired in appearance and do not encourage potential visitors, be they either local residents, school visitors or holiday makers passing by. The signs do not communicate that the Gardens have a fascinating heritage or that they are even open.</p> <p>We understand that the bowls club is active and thriving and we presume that guest teams and players know where the club is and how to access it.</p> <p>These two signs are supplemented by a small timber notice on the new side entrance gate.</p> <p>Inside the Gardens there are a number of signs informing visitors about matters of ecological interest and red squirrels in particular.</p>

<p>Queen's Gardens sign at the west gate</p>

<p>Modest sign on the side entrance</p>	<p>Note discussion about signage above.</p> <p>Design new 'house-style' signs for the Gardens, intended to be more visible where it is necessary, and more inviting to read. These should not be over-elaborate, but high-quality & well-maintained.</p> <p>Update & maintain interpretation board within the Gardens.</p>

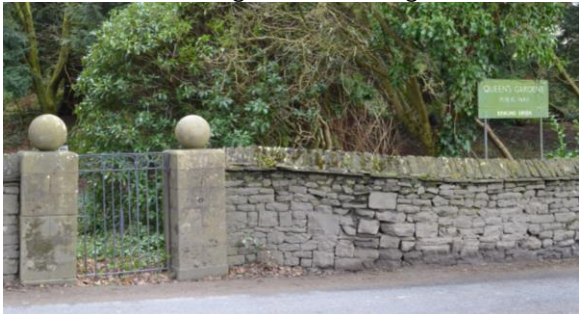
<p>Queen's Gardens sign at the east gate</p>

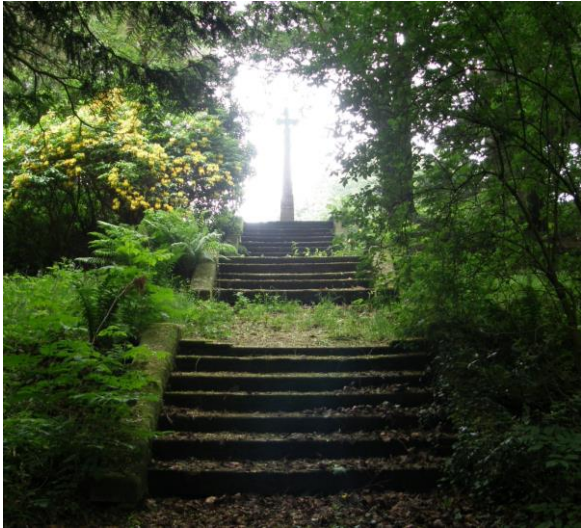
<p>View of the cross from the base of the steps</p>

<p>View of the cross from the circular lookout</p>	<p>It is important to undertake judicious tree / shrub management on a regular basis to ensure that the views of the memorial along the central axis are maintained and enhanced.</p> <p>Photographic record should be maintained to inform the work programme.</p>

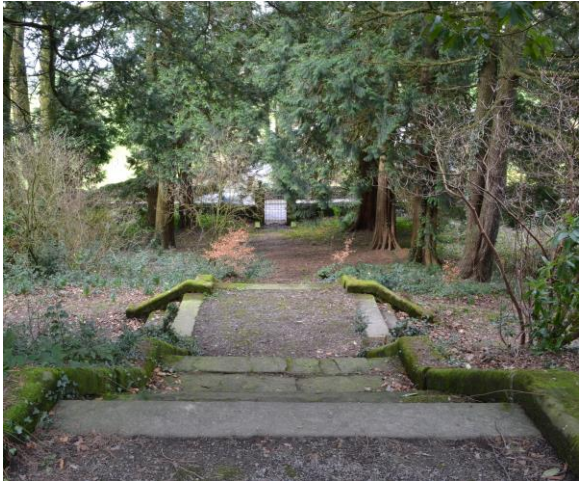
<p>View of the Howgills to the north of the Gardens hidden by the mature thuya and other conifers</p>

<p>View of the hills to the south of the Gardens impeded by shrub and tree growth</p>	<p>Prepare simple plan of all key views, which will require to be monitored and managed on a regular basis.</p> <p>With care, study whether it would be possible to open 'keyhole' views northwards, towards the fells from the top of the steps – without damaging setting of and approach to the cross.</p>

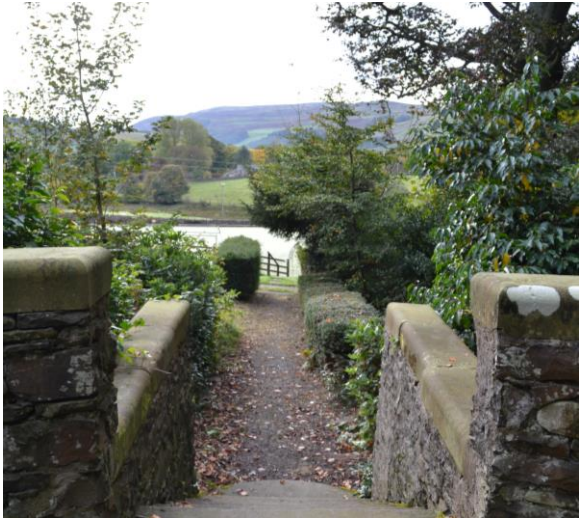
<p>View from the circular lookout southwards</p>

<p>View from the circular lookout to the south-east</p>	<p>With care, reopen & frame views southwards, especially from the lookout bastion.</p>

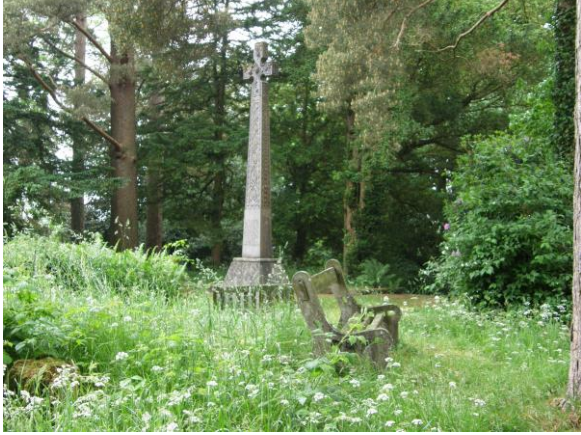
<p>View of the cross from east glade</p>	<p>The glades which are setting for the cross and principal walk should be treated as garden. Remove all cuttings, brash & other unwanted vegetation. Maintain maximum control over bramble.</p> <p>On W & E of main path, consider groundcover planting (some of which is already there). Always plant in spreading, rhythmic, groups: bluebells & other bulbs, woodruff, vinca, foxgloves, various umbellifers, hypericum etc., as well as grasses. This would be managed by mowing and removing arisings 2 or 3 times in late summer. Around the outer edges, small ornamental trees & flowering shrubs, as recommended by Mawson: pink hawthorn, Deutzia, Amelanchier, Berberis darwinii. Azaleas & Rhododendrons are key plants for Mawson, in this kind of setting.</p>

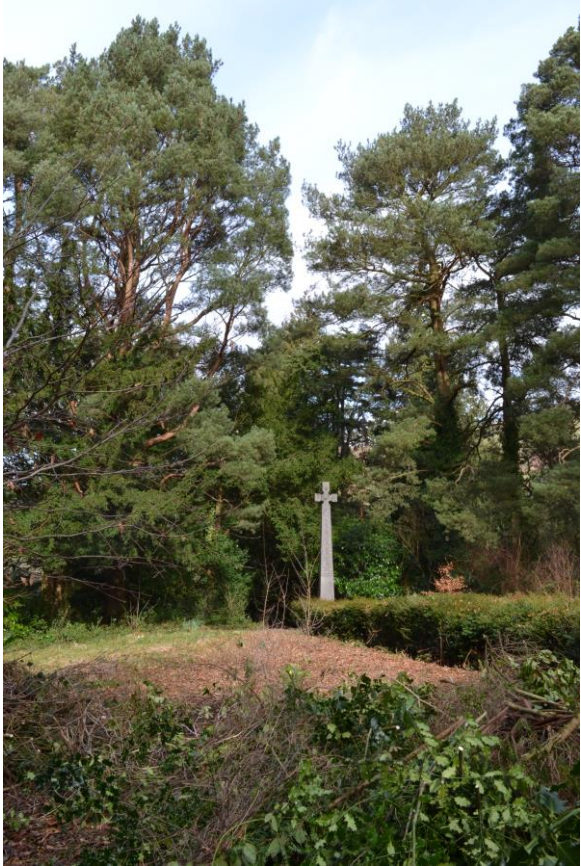
FEATURES	DESCRIPTION & CONDITION	SIG	QUEENS GARDENS SEDBERGH GAZETTEER	RECOMMENDATION	ACTION NOTES
<p>VIEWS & VISTAS</p> <p>SW - SE OF THE MEMORIAL</p> <p><i>(continued)</i></p>	<p>It is acknowledged that the SW glade has been cleared of bramble and other scrub growth to provide long views of the cross against the dark backdrop of Scots pines and yew. The open glade importantly also offers views of the veteran cherry on the glade's south bank.</p> <p>Overgrown / etiolated hollies & yews – as well as rough scrubby growth – in both SW & SE side of cross do not provide effective back-drops to either the cross or any flowering / ornamental plants.</p>

<p>View of the cross over the west glade</p>	<p>Selectively, and by degrees, reduce some hollies & yews to promote thicker growth. These will then provide better setting for the open glades & any ornamental plants growing therein.</p>

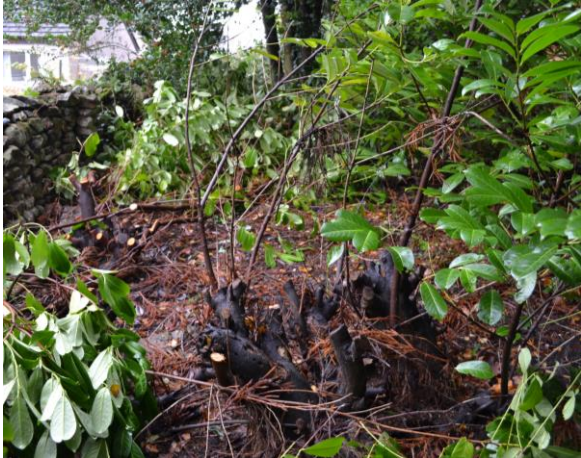
FEATURES	DESCRIPTION & CONDITION	SIG	QUEENS GARDENS SEDBERGH GAZETTEER	RECOMMENDATION	ACTION NOTES
<p>USE & MANAGEMENT</p> <p>CHRONIC ISSUES</p> <p><i>(continued)</i></p> <p>Green Waste</p>	<p>The site is small, and has no sort of depot facility and, while it can be argued that pruning, cutting and mowing equipment can be brought in as required, by a small van, the disposal of green waste remains a real and problematic issue.</p> <p>Mike Hinson reported (above) that the explorer scouts had cleared invasive plants etc. and quite probably the biggest job on the site is the pruning, cutting and collecting of unwanted scrub, shrub, tree arisings and leaf litter.</p> <p>At the moment, arisings are distributed throughout the Gardens including the scrub/shrubberies to the south-east of the circular lookout and inside the west and, more noticeably, the east boundary wall - it may be that residents in the houses adjoining the Gardens undertake their own pruning of overhanging branches and leave the arisings in the Gardens.</p> <p>There are indications that attempts have been made to manage the problem in the past as can be seen by the remnants of a leaf litter basket against the west wall near the car park – but the problem is of a greater order.</p>

<p>Arisings by the east wall</p>

<p>It is <u>essential</u> that the problem of managing green waste and other arisings is resolved. Given the limitations of the site, we believe that the only option is regularly & frequently to remove all the waste from Queen's Gardens & store / compost / recycle it elsewhere.</p>
